-
Ontario Ministry of Mines
Category C Environmental Assessment
Project Documentation
Gould Copper Mines Rehabilitation Project

Mine Rehabilitation Section
Mines and Minerals Division

Last Revised: October 23, 2023

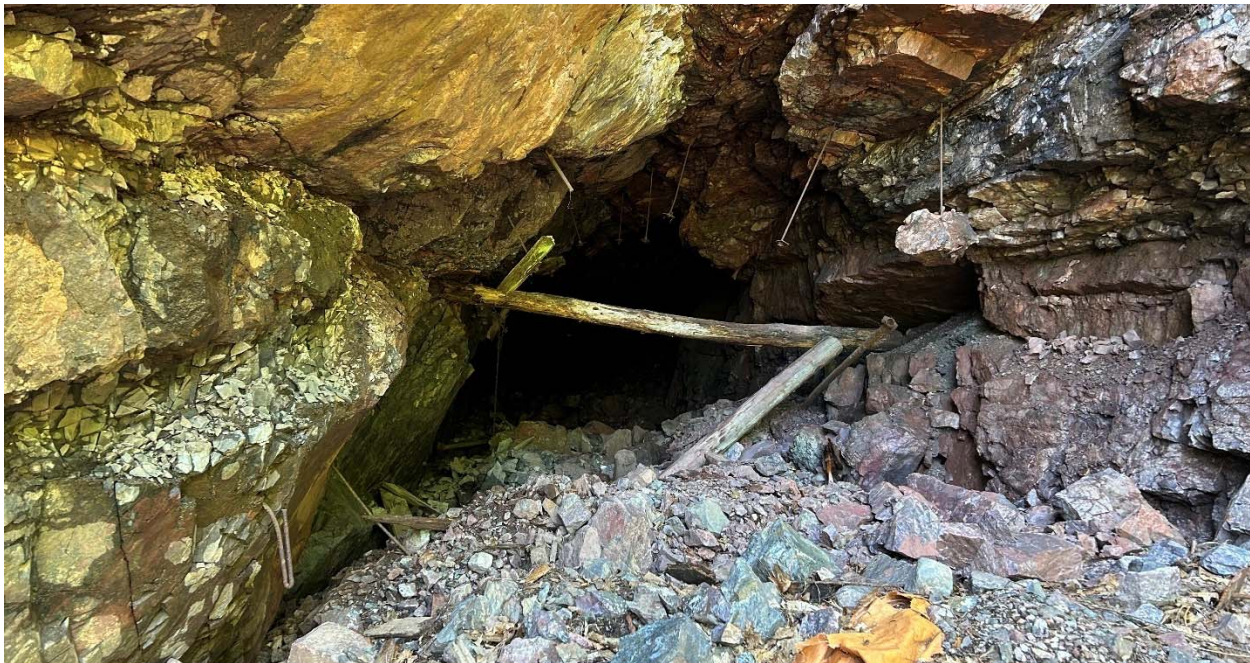
Photograph 1 – Adit proposed for rehabilitation. Note the presence of fallen timber and rocks indicating failure of the adit brow and crown pillar (June 28, 2023).

The proposed rehabilitation approach for the adit is to backfill a minimum of 10 m of the adit from the brow to support the crown pillar and prevent it from unravelling. The backfill will also be used as the rehabilitation measure to permanently prevent access to the adit but will result in the permanent loss of potential bat overwintering habitat. The preferred rehabilitation strategy for the two raises is to backfill using a combination of cemented and uncemented material to maintain long-term stability. Mine infrastructure to be decommissioned includes the hydro substation, mill site foundations, water tank, and two steel barrels. Disturbed areas will be allowed to revegetate naturally to match surrounding habitat. The location of mine hazards to be rehabilitated are provided below on Figure 2.

The only feasible permanent rehabilitation measure identified for the adit and adit crown pillar is to backfill. The backfill would be placed a minimum of 10 m inside the adit from the brow to support the crown pillar and prevent it from unravelling. The backfill would extend in front of the brow, mounded approximately 2 m above the brow and sloped to ensure the long-term stability of the material. The work will occur in the early summer when bats are not expected to be utilizing the underground workings as a potential hibernaculum and is expected to take approximately three days to complete. The advantages of the above rehabilitation strategy are as follows:

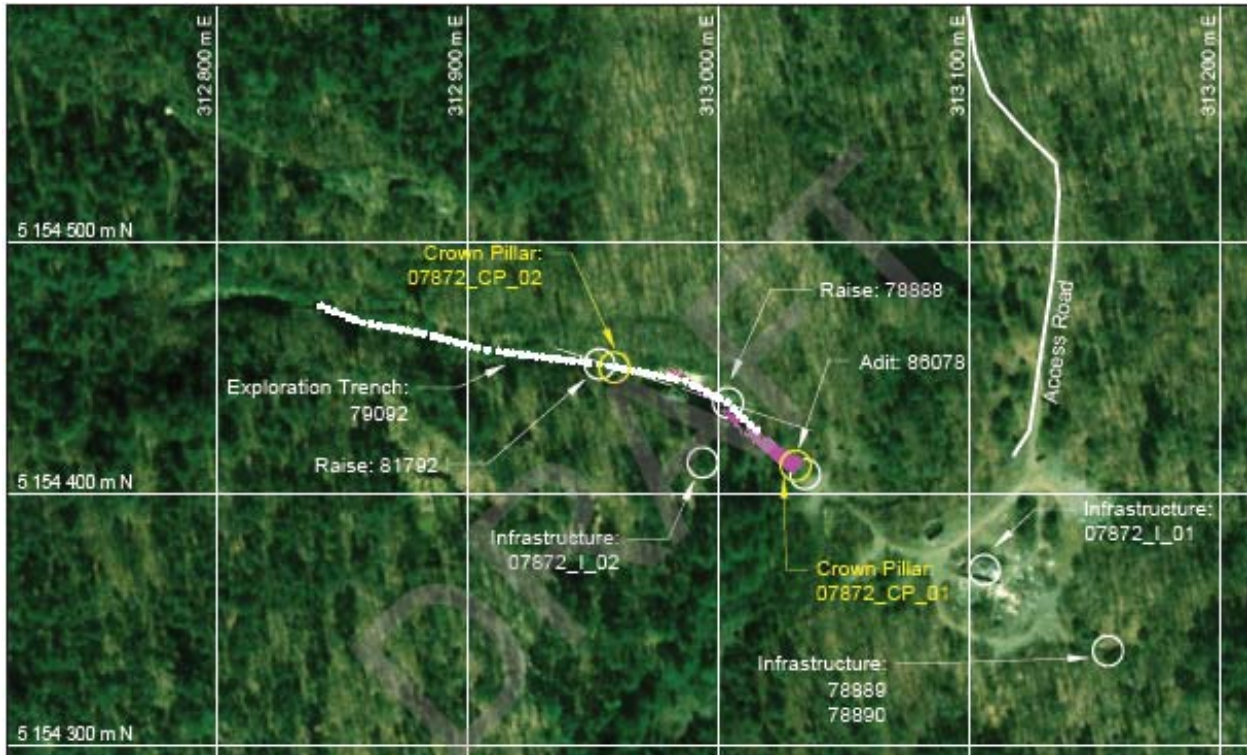
Figure 2 – Location of mine hazards proposed for rehabilitation. Image source: Golder Associates Ltd. (2021).

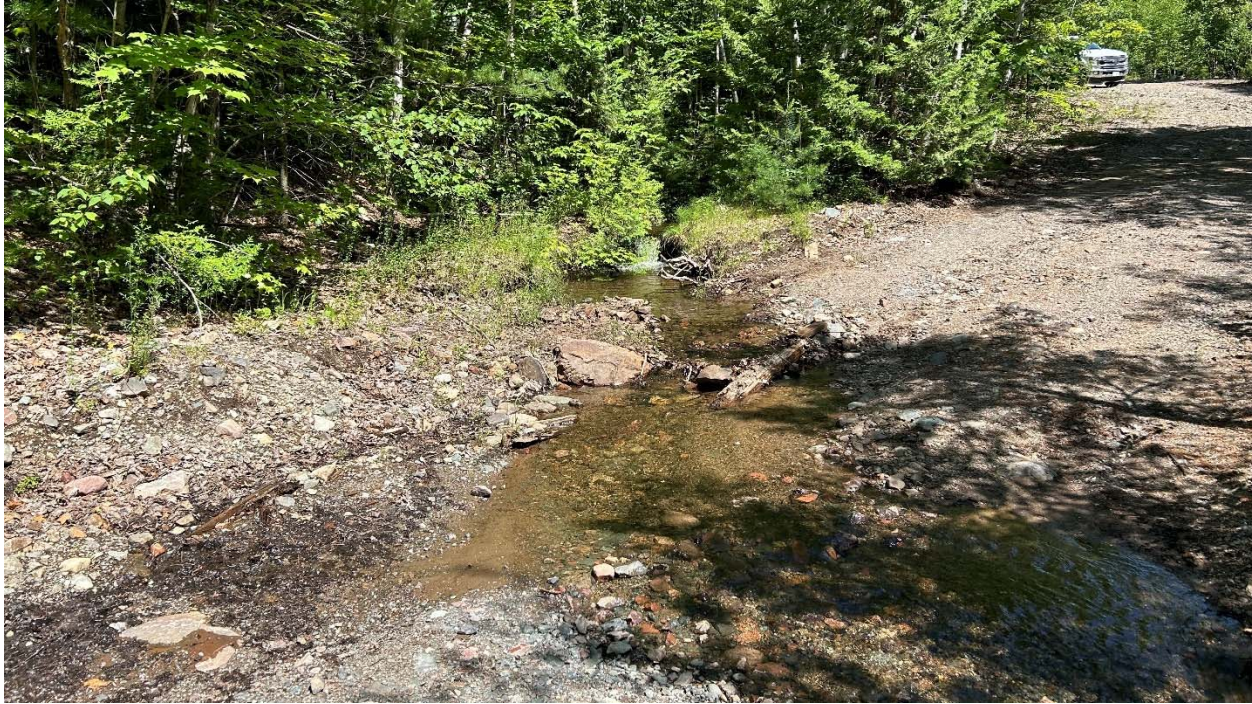
Photograph 2 – View of the intermittent creek transecting the mine access road facing northeast. The creek flows in a southerly direction and eventually empties in Huston Lake. (June 28, 2023)

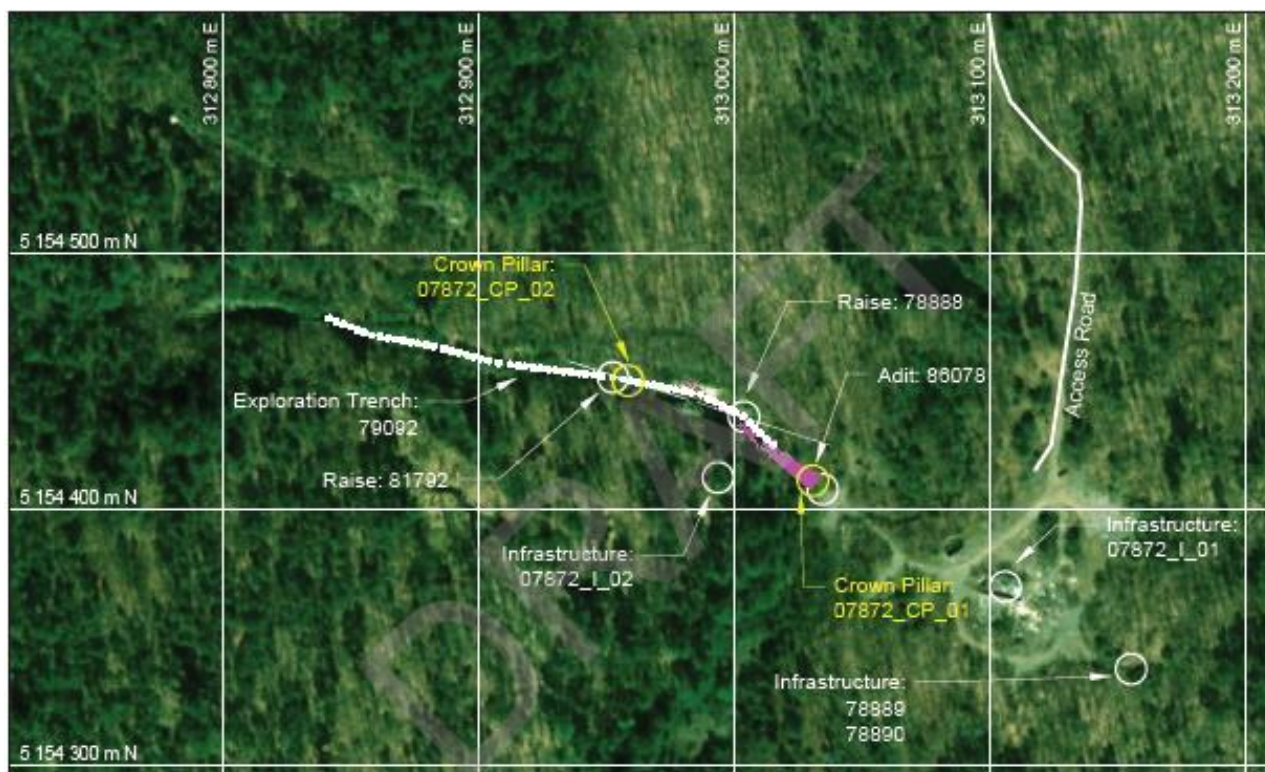
Figure 2 – Location of mine hazards at Gould Copper Mine property. The boundary of the project area is defined by the mine access road and area surrounding the mine hazards.

Other mine hazards to be addressed as part of the rehabilitation work includes two raises to surface and the remnants of various mine infrastructure. The location of all mine hazards on the property are illustrated below on Figure 2. The preferred rehabilitation strategy for the two raises is to backfill using a combination of cemented and uncemented material to maintain long-term stability. Mine infrastructure to be decommissioned as part of the rehabilitation work includes a hydro substation, mill site foundations, a water tank, and two steel barrels. Disturbed areas will be backfilled and landscaped, as required, and allowed to revegetate naturally to match surrounding habitat.
